Underwater Sensor System 2009 Field Trial Report

Northern Watch Technology Demonstration Project

Technical Memorandum

DRDC Atlantic TM 2010-241

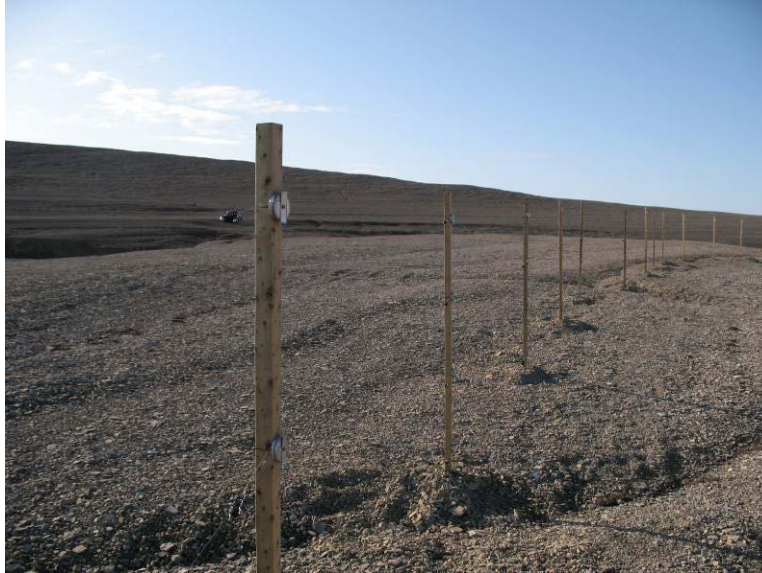
Figure 4. A view of some of the 95 posts that comprise the bear fence. The banana plug couplers and the aluminium disc with spring-steel clamps are clearly visible on the foreground post.

This fence significantly improves camp security and has operated extremely well. Only 3 false alarms were generated during the trial. These false alarms were caused by the wind blowing a cardboard box or other loose item through the fence. A number of other false alarms were generated by people trying to climb through the fence without turning it off. In the future, three gates will be added that will allow people to enter or leave the camp without disabling the alarm. A garbage box will be built to contain loose cardboard and bags to ensure that they are safe from animals and unable to blow around.

The bear fence was expensive in both materials and set up time; however, it is functioning extremely well and has provided a strong sense of security. The fence is superior to anything commercially available and attracted the attention of a visiting Wildlife Officer who would like a similar device for the garbage dump at Resolute.

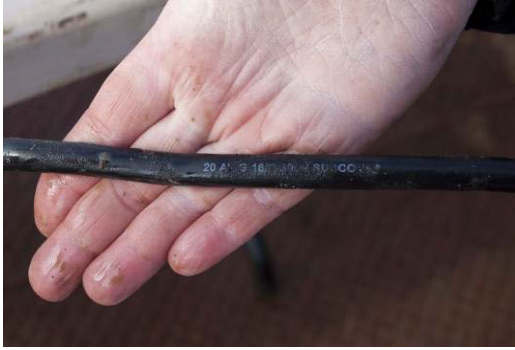
On recovery of the cable we discovered that the “pigtail” portions of the cable had been partially eaten by marine life. One of the pigtails was eaten to point that some copper was exposed to the seawater. This particular problem could also have been caused initially by abrasion and then being nibbled by critters.

Figure 5. Rubber pigtail that has been partially eaten by sea life.

Observation showed that vinyl tape covered regions were unaffected by the nibbling. We covered the pigtails in the new deployments with tape to ensure a longer life time. We also added additional protection to couplings to avoid abrasion problems as much as possible.

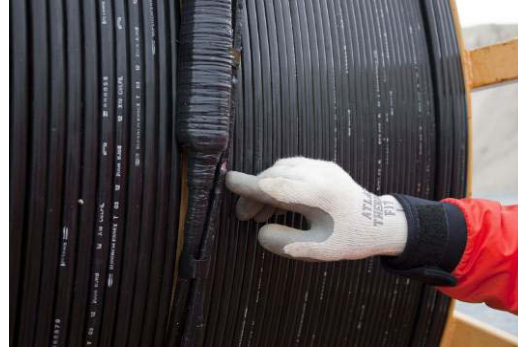
Figure 6. Copper wires were exposed on one part of the recovered cable. It is uncertain if the cause was abrasion or nibbling by sea life.

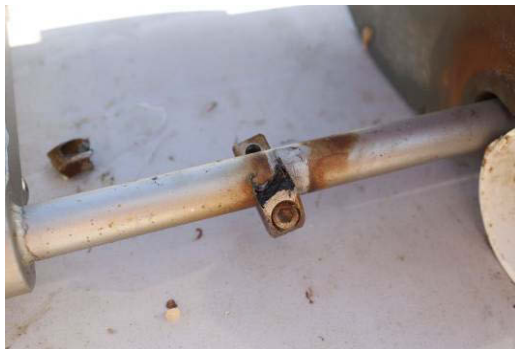
The recovered repeater nodes showed significant corrosion. Despite the all stainless steel construction of the support cages, corrosion of certain parts was excessive. There are a number of small collars that hold the canisters in position within the stainless steel cages. All of these collars were significantly damaged. Several were missing completely. Significant corrosion was also seen at steel mating surfaces. The rate of the corrosion was much higher than expected and may indicate lower than normal oxygen content in the water.

Figure 7. Stainless steel retaining collars were all severely damaged by corrosion. Several were missing completely.

By examining the corrosion we have learned some valuable lessons and can now design cages with longer structural lifetimes. We estimate that the mechanical integrity of the existing cages will be lost within three years. The design goal was two years. While the loss of structural integrity would make system recovery difficult, it is not likely to prevent the cable system from operating electronically. The electronics canisters were all plastic and showed no appreciable wear.

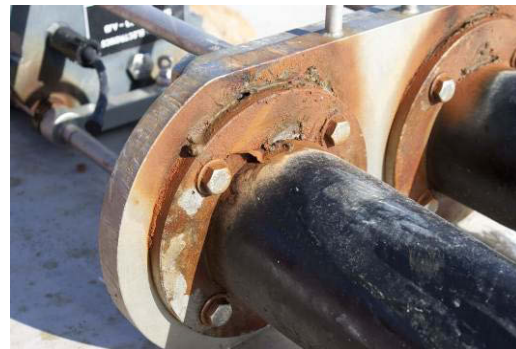
Figure 8. Stainless steel corrodes where oxygen is excluded. This typically occurs at mating surfaces as seen here.

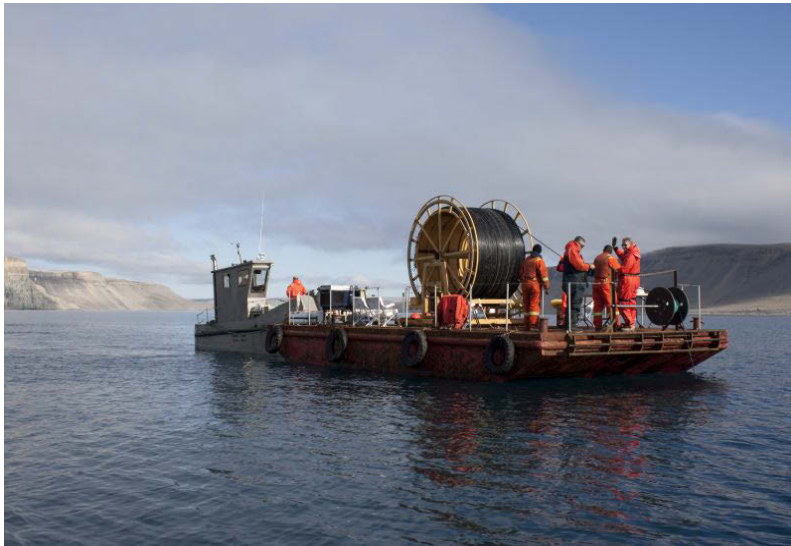
Figure 9. *A dumb barge with safety stanchions attached is lashed to an SP barge at rear.*

During the recovery of the cable we used a large diameter powered reel and a dumb barge pushed by an SP barge from *Terry Fox*. This mechanism and vessel combination worked extremely well. It is a reliable mechanism for recovery of the cable and can be used in low sea

states with good success. A purpose built system of similar, but faster operation would be ideal for cable recovery operations.

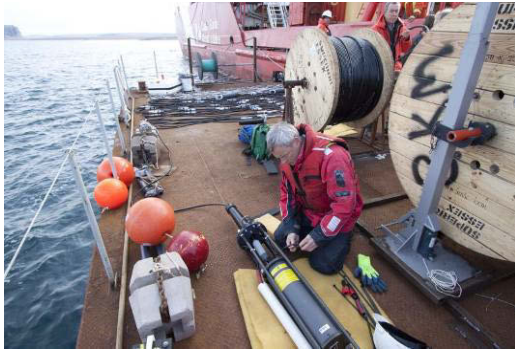
Figure 11. Dan prepares one of the cable nodes for deployment. Note the cable reels that were used to hold the independent cable sections.

The main cable was deployed from the wooden cable spools on which the cable was delivered. Jack stands were welded into frames to support the reels on the barge. Batteries and wireless array controller systems were attached to the sides of the reels to allow real-time monitoring of the array condition during deployment.

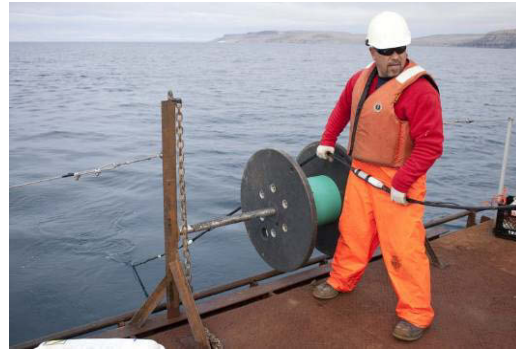
Figure 12. Al deploys an array by hand using the large diameter pulley at the front of the barge.

The array components were flaked on deck and hand deployed under tension while the length of system paid out and the motion of the vessel was tracked using GPS. This constant comparison and control is required to ensure a straight stretched out lay of the array and to ensure that the array is not dragged too far. It also ensures that the cable is laid as expected and not simply being dragged out by the current flow.

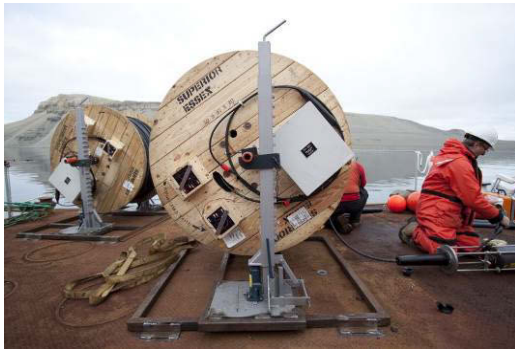
Figure 13. A view of the unpowered cable reels mounted on the jack stands. Note the wireless, battery powered array controller systems on the cable reels. The wireless systems allowed continuous confirmation that the array was functional during deployment.

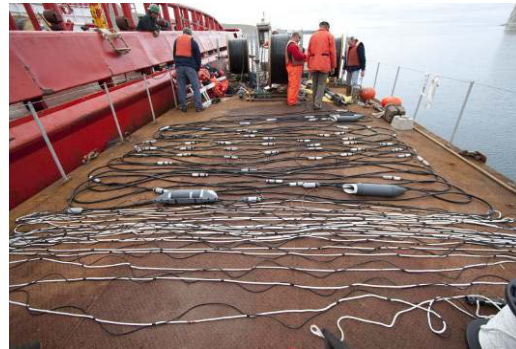
Figure 14. A Northern Watch array flaked out for deployment on the deck of the dumb barge. The cable reels are at the far end of the deck.

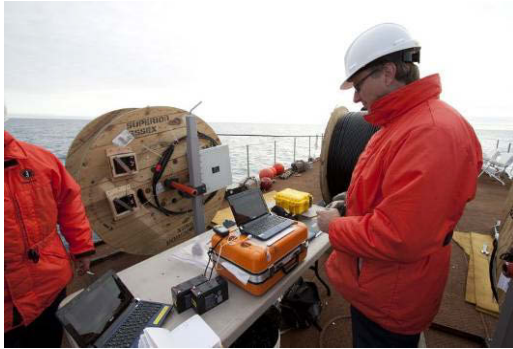
Figure 15. The navigator monitors the rate of cable lay and the vessel position.

The tasks of deployment were broken into the following jobs. Boat driver, Mate, array/cable handlers, and navigator. Extra people were on board to allow people to be relieved and also to lay hands as required should the need arise. The boat driver was the Chief Mate of the CCGS *Terry Fox*. He drove the vessel under the influence of instructions from the Mate and the navigator. The Mate watched the cable lay and kept the vessel aligned by verbal instruction to the driver. The Mate also watched for safety issues and kept control of the deck. The cable/array handlers lifted the array components over the side, released or held the cable as required, assembled the repeaters, coupled the cables, and moved batteries and wireless units as necessary. The navigator was responsible for ensuring that the position and progress of the

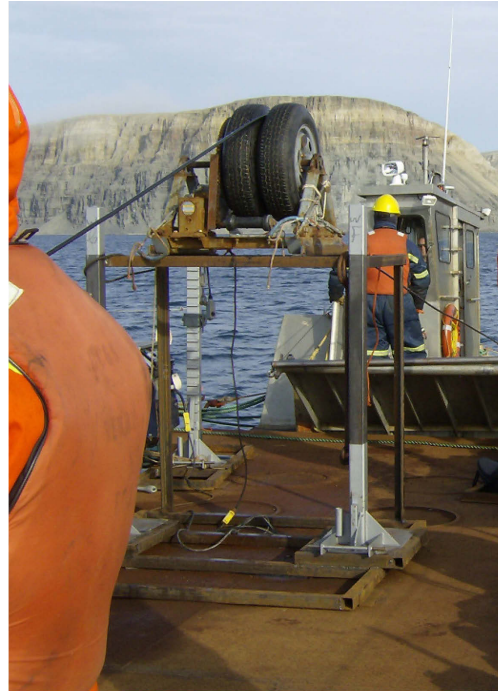
Figure 16. The 'Mule' provides a convenient means of pulling on the cable without kinking it and can be quickly separated from the cable when necessary.

The recovery of Array 1 was accomplished by using a “Mule.” The mule consists of a pair of trailer tires mounted side-by-side such that the side walls of the tires are almost touching. The rims are mounted on a common shaft that is driven by a chain reduction drive and a screw-drive with friction clutch. Lines or cables can be positioned between the tires and by simply

applying a downward pressure on the line or cable before and after the mule a variable degree of friction can be used to pull the line or cable. It is a simple matter to lift the line or cable out of the tires to reduce friction or completely free the line. The mule can be driven in either direction and stopped or started instantly. This pulling device is ideal for gently handling the array cable. It also works well with the anchor lines.

Using the mule we were able to easily and safely under-run the cables at will. Short pauses at the repeaters allowed us to walk the repeaters over the vessel and safely pass them off the stern.

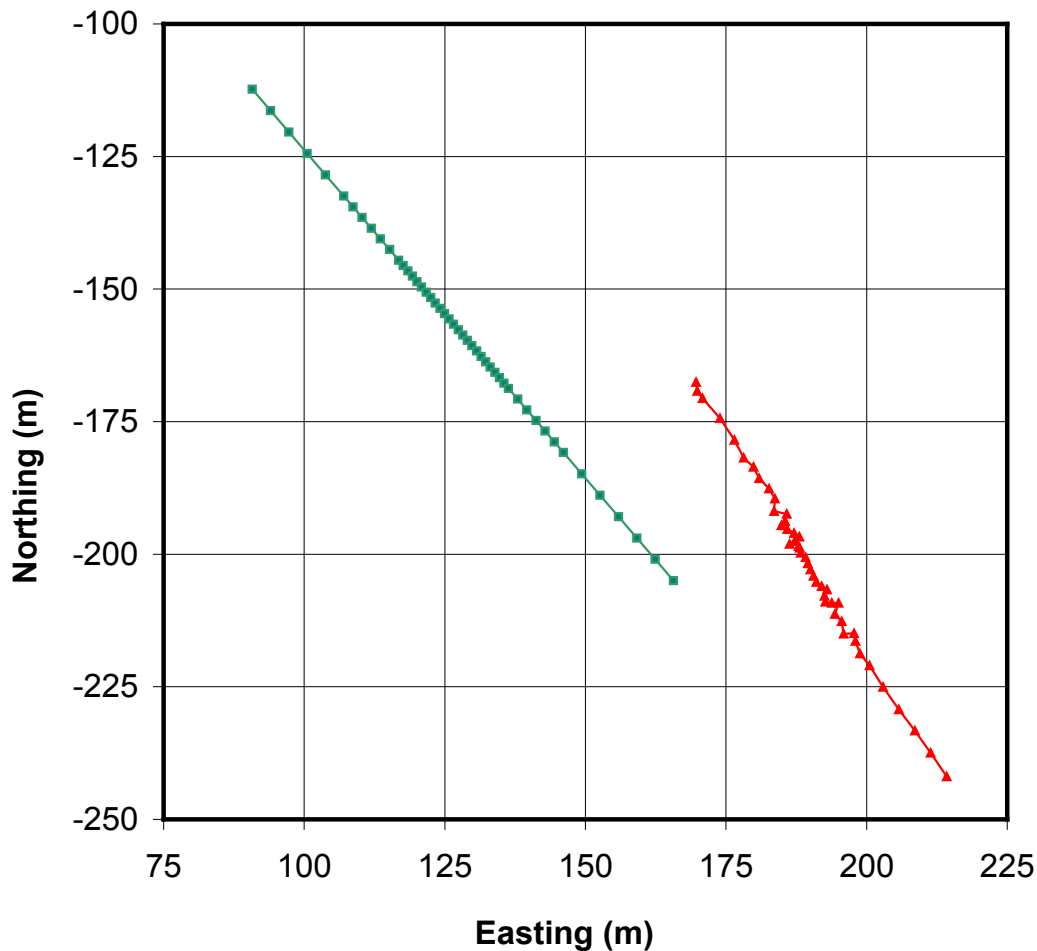
As expected the results for Array 3 show that the array is not fully extended. The latter two-thirds portion of the array is not fully spread. The array is about 50 m west and 40 m south of the initial estimate.

Figure 18. Array element localization results for Array 3. The original position estimate in green and the final result in red.

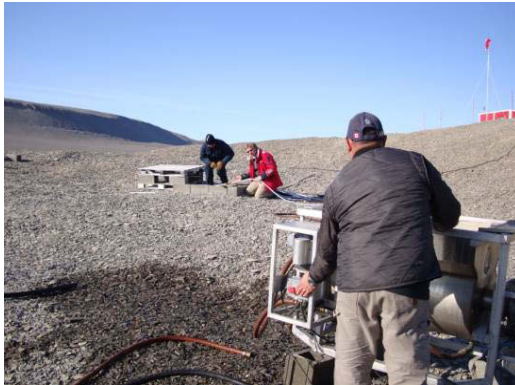
The free end of the PEX tubing was pushed into the hole and we discovered that we could insert the tubing 7.3 m (24 ft) before encountering an obstruction. At this point water was pumped into the pipe and we allowed the pipe to fill and observed water overflowing and disappearing into the gravel. The heat was then turned on and the PEX tubing was repeatedly inserted and withdrawn a short distance from the pipe. Very soon we observed that the tube was advancing when the water was hot.

Figure 19. *AI operates the hot water drill, while others feed the PEX tubing into the pipe.*

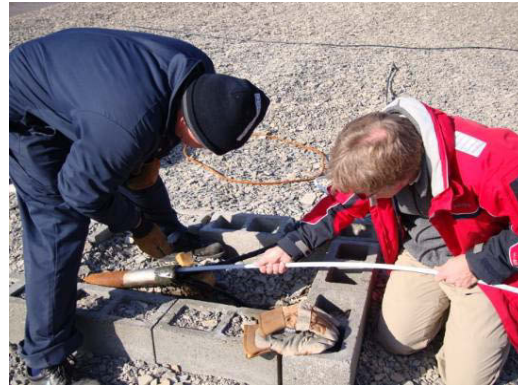
Figure 20. *Val and Garry feed the PEX tubing into the pipe to melt the ice securing the cables.*

It is clear that it is an easy matter to free the pipe of ice. The hot water drill technique is a workable method. Unfortunately, the cable is buried under a sufficient quantity of gravel to preclude easy removal. Divers will be needed to open the seaward end of the pipe. The two important points are that the pipe is intact and the melting method is relative easy to use.

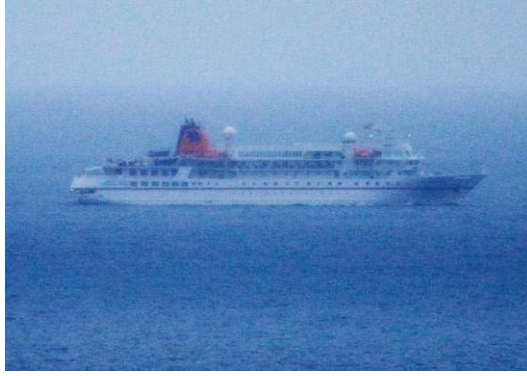
Figure 22. Photograph of the Bremen taken in low light and mist at a range of 8 km.

Figure 21 shows the resulting sonagram generated with data from Array 2 as the *Bremen* passed the CPA (closest point of approach). Using a 300-m telephoto lens we were able to photograph the ship in poor light and mist conditions of early morning (Fig. 22). The ship was at a range of approximately 8 km when it was photographed.

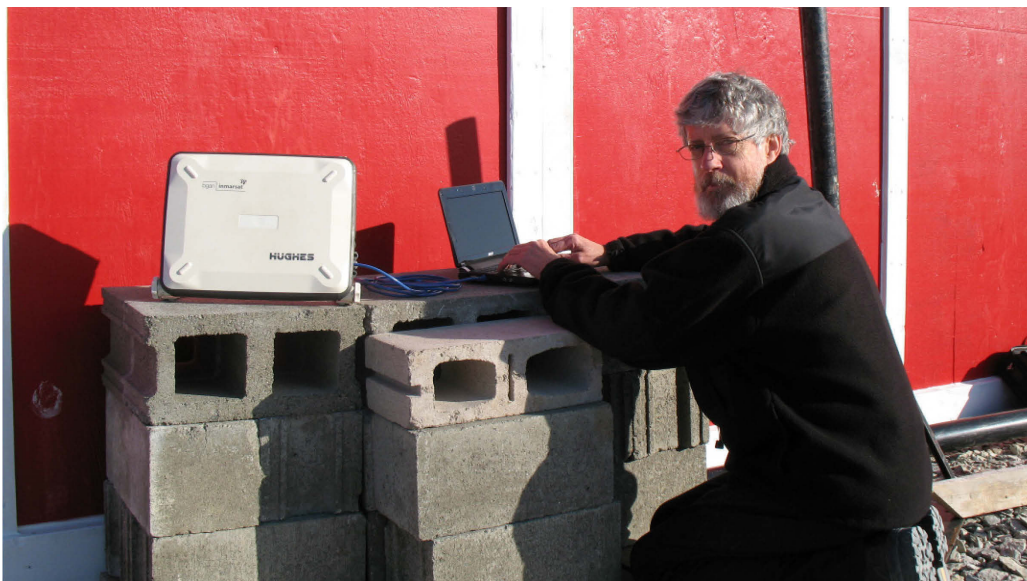
Figure 35. Gord prepares a message to transmit south using the BGAN portable satellite system.

Unfortunately, the satellite communications system used last year was unavailable this time around. We did not know this until it was too late to make other plans. Some qualitative data were collected by employing a brief-cased sized BGAN satellite communications system. This system uses INMARSAT satellites and it was not initially known if it would work at this latitude.

We used the BGAN to transmit messages south over the Internet with great success. We had relatively good bandwidth as there were likely no other users in our sector. Unfortunately, the BGAN system can be expensive to use and we minimized operations as the costs can quickly build using this device, particularly in data-streaming mode.

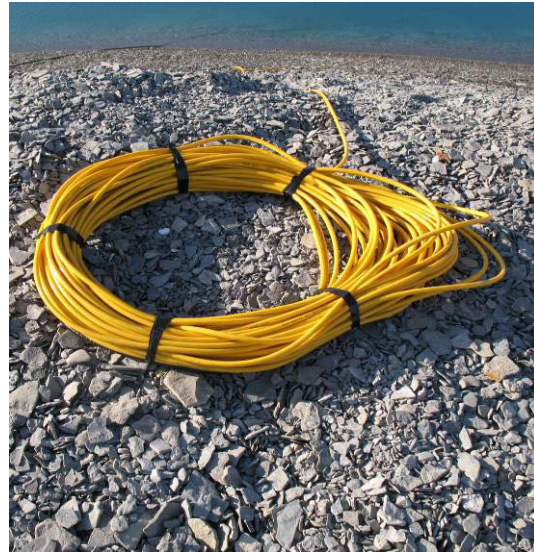
Figure 38. This bundle is the end of the BIO cable. It was dumped in the water near Walrus Point for safekeeping over the winter.

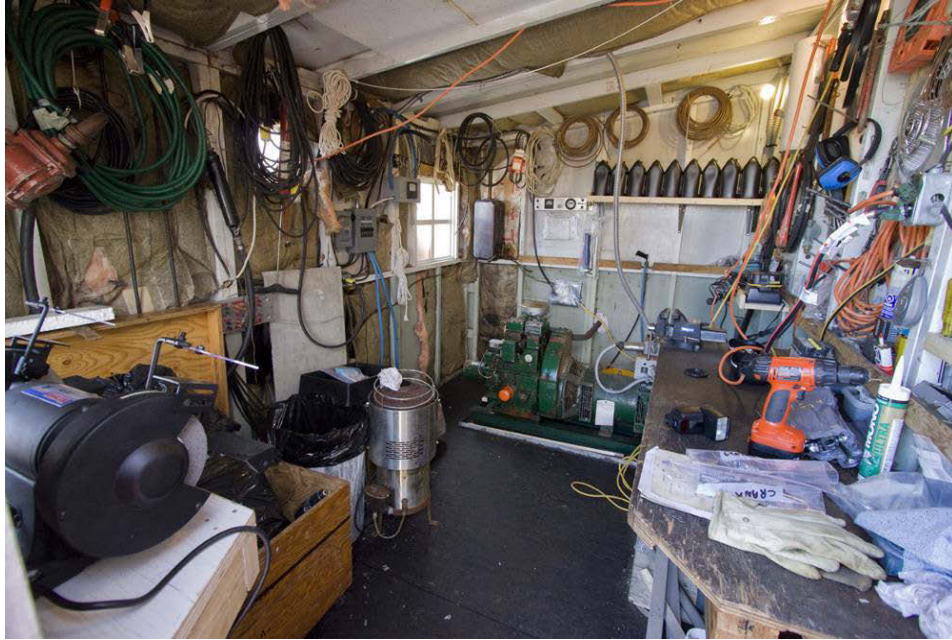
Figure C10. Interior view of Generator Shed G3.

The generator hut and toilet area (building G3) require more improvements. These will be made in the near future. The most significant improvement is the repair of the Lister diesel generator, which failed on the first day at camp. The Lister is an old machine, but one of high quality. The failure was caused by a cracked fuel injector that can be easily replaced. The camp ran on two 5.5 kW Yanmar portable diesel generators, but these should be built into an expanded generator shed and used primarily as backup systems. In addition, the Lister generator breaker switch and output wiring as well as the electrical distribution panel are in need of a complete replacement. Annex D provides a summary of the camp electrical.
